TAC meeting Oct 2013

Activity 3 presentation

Field work

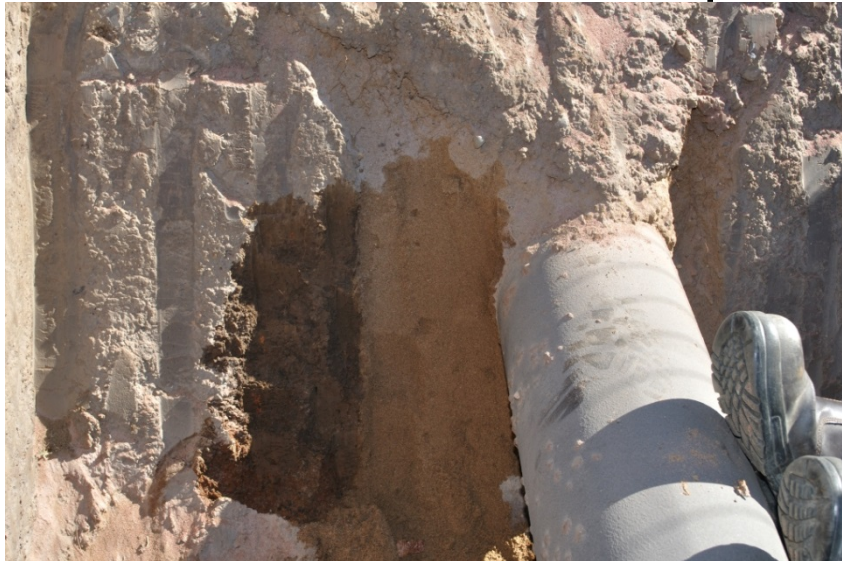
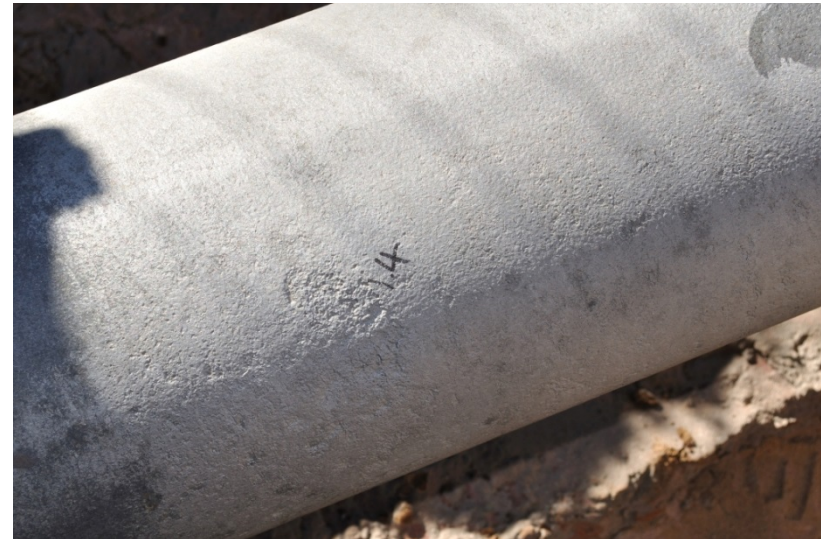
- Site BE7
- Example of good quality sand surround.
- Pipe in excellent condition
- Corrosion less than expected were pipe in native soil

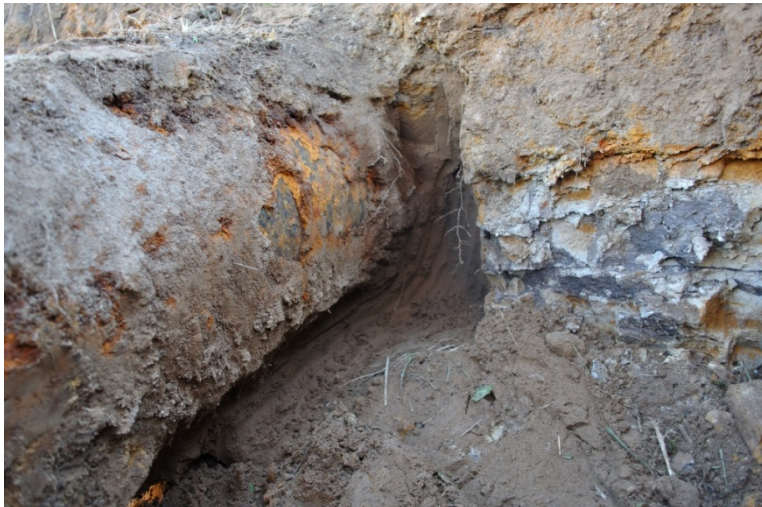
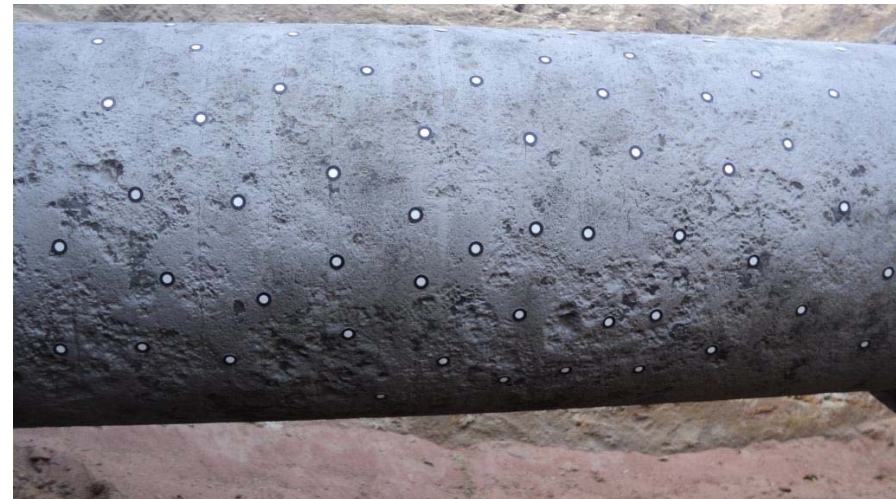
- Site BE5
- Poor quality sand surround.
- Native clay soil interspersed. Touching pipe.
- Corrosion similar to native clay sites

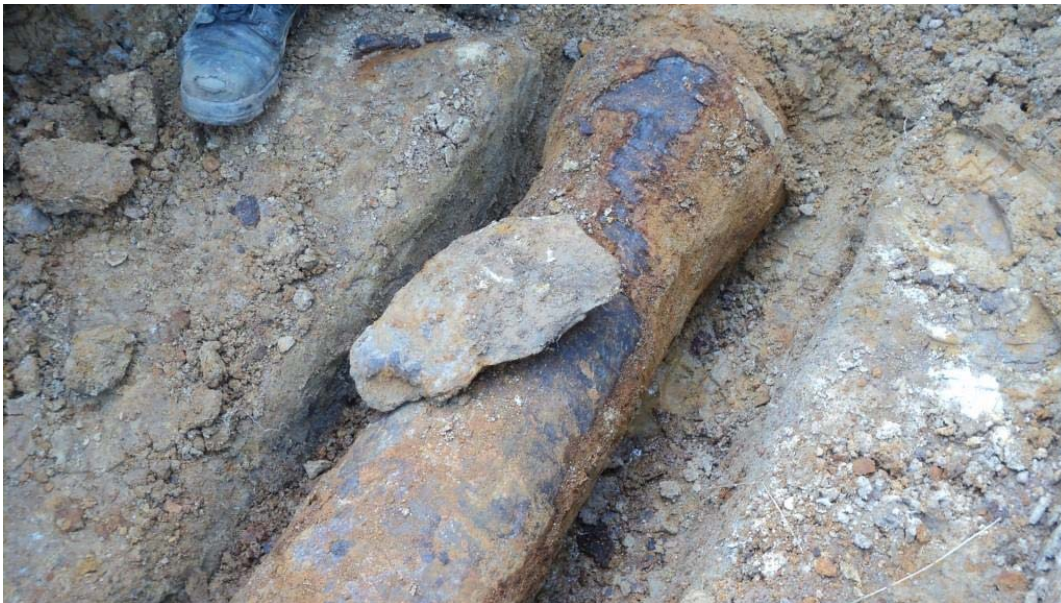
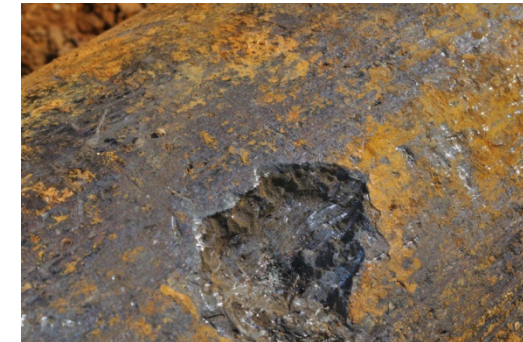
HW CA 2013 CE2 site photos

- Left out of original analysis
- Native sand backfill sites:
- Low confidence on long-term average moisture content.
- Other sites –site specific factors or incomplete inspections made difficult to analyse
- Noteworthy “other” site: CE2 - rocks in fill > higher than expected corrosion
