TECHNICAL NOTE

Project: Advanced Condition Assessment & Pipe Failure Prediction Project (ACAPFP)

Title: Review on Harris Street/Ultimo Lane Water Main Failure

Ref.: Monash-ACAPFP-
Activity1-TN1

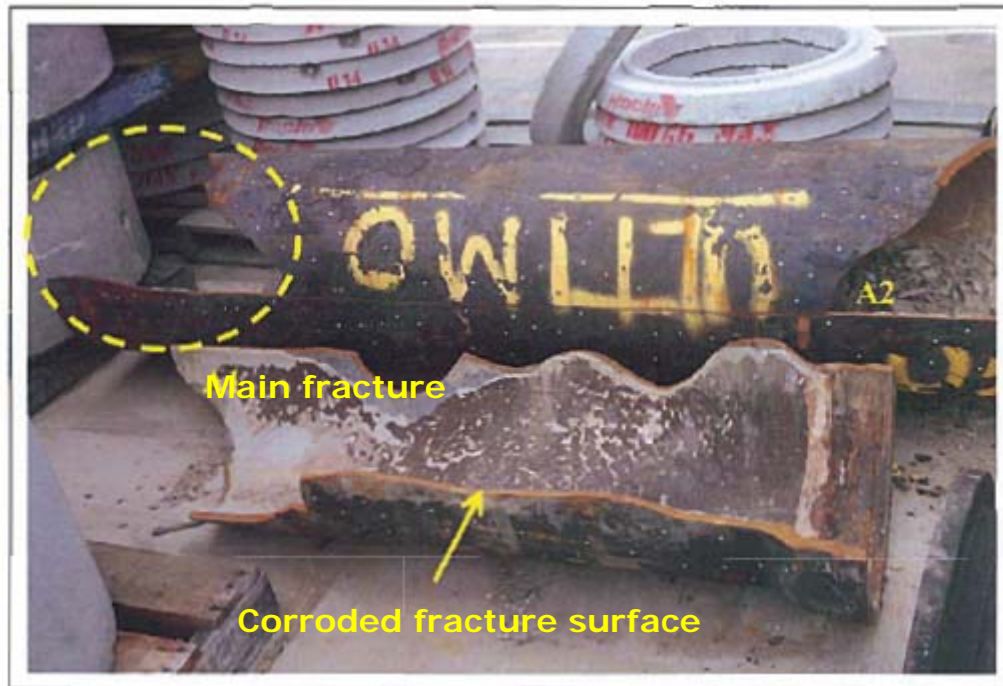
This report provides a preliminary evaluation of the pipe failure at the intersection of Harris Street and Ultimo Lane that took place at 11.05pm on the 10th of August, 2013. The failure occurred in a 500mm diameter cement lined spun cast pipe laid in 1961 (Figure 1-1). The road surface was a bitumen covered concrete surface (250 mm thick), and the pipe burial depth to the pipe crown was about 1.6m. Figure 1-2 shows some pictures indicating the location and some consequences of the failure. Herein, this failure is referred to as "Harris/Ultimo pipe failure". As part of Activity 1 of Advanced Condition Assessment and Pipe Failure Prediction (ACAPFP) Project, a study has been undertaken to investigate the drivers of failure; thus to put forward an explanation (a hypothesis) on how the failure may have eventuated.

(a) Water main viewed on 22nd Oct 2013 (Ref. [Error! Reference source not found.])

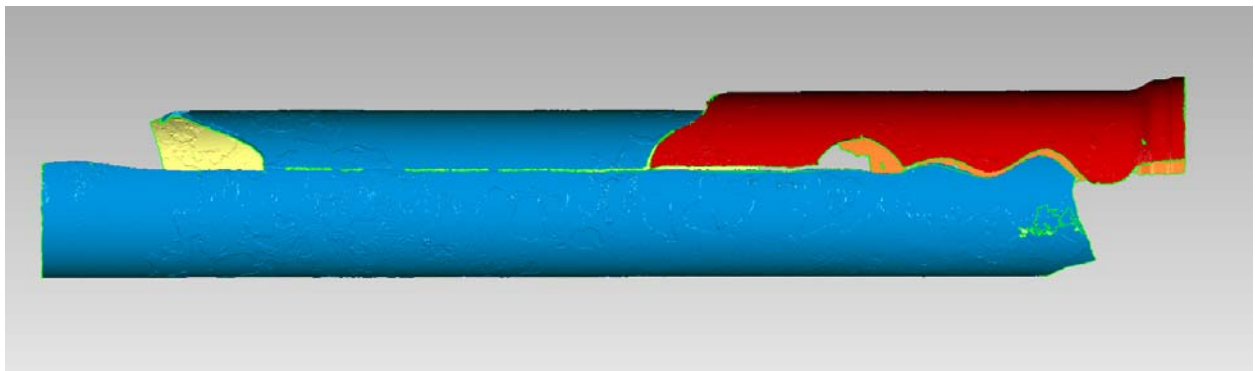
(b) Scanned image of the main using 3-D scanner (Ref. [Error! Reference source not found.]) with the curtesy of University of Technology Sydney (UTS), ACAPFP Partner)

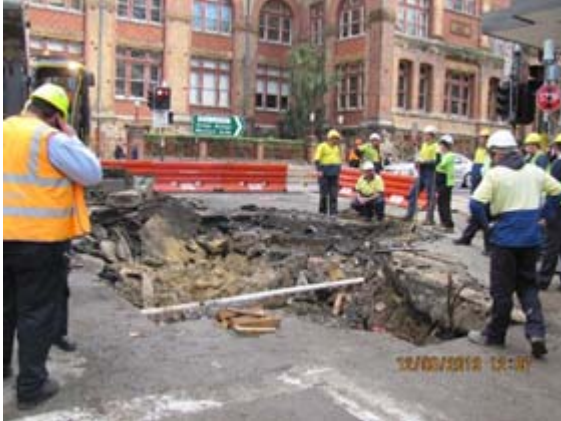
(a) Failure site (Ref. [6])

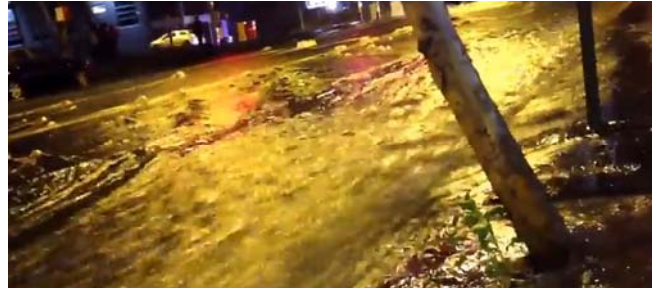
(b) Water flooding to adjacent streets (Ref. [4])

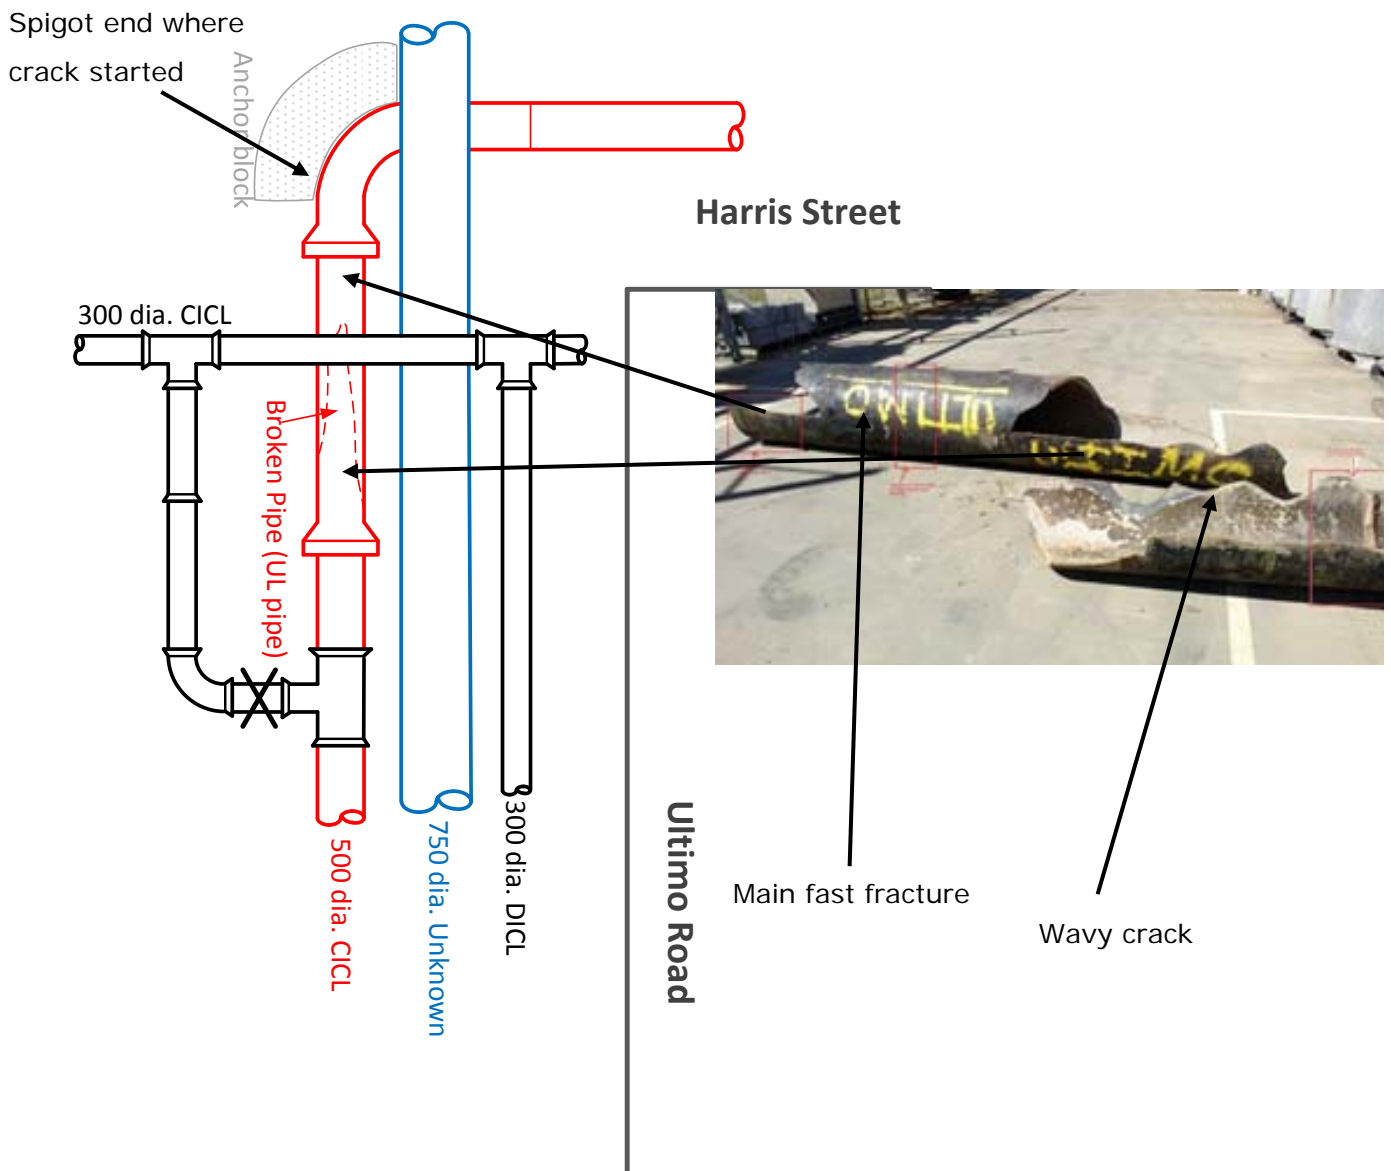
Figure 2-1 Pipe layout of the failed pipes along with connections and other adjacent pipes (Modified from Ref. [7])

The layout of the failed water main is shown in Figure 2-1 along with the adjacent pipes. It appears that there were 2 more pipes laid adjacent the failed pipe (D500). A pipeline of diameter 750mm was laid above the failed pipeline (with a gap of more than 100mm between the failed pipe and D750 pipe, Ref. [8]) and another pipeline of D300 was connected to D500 pipeline as shown in Figure 2-1.

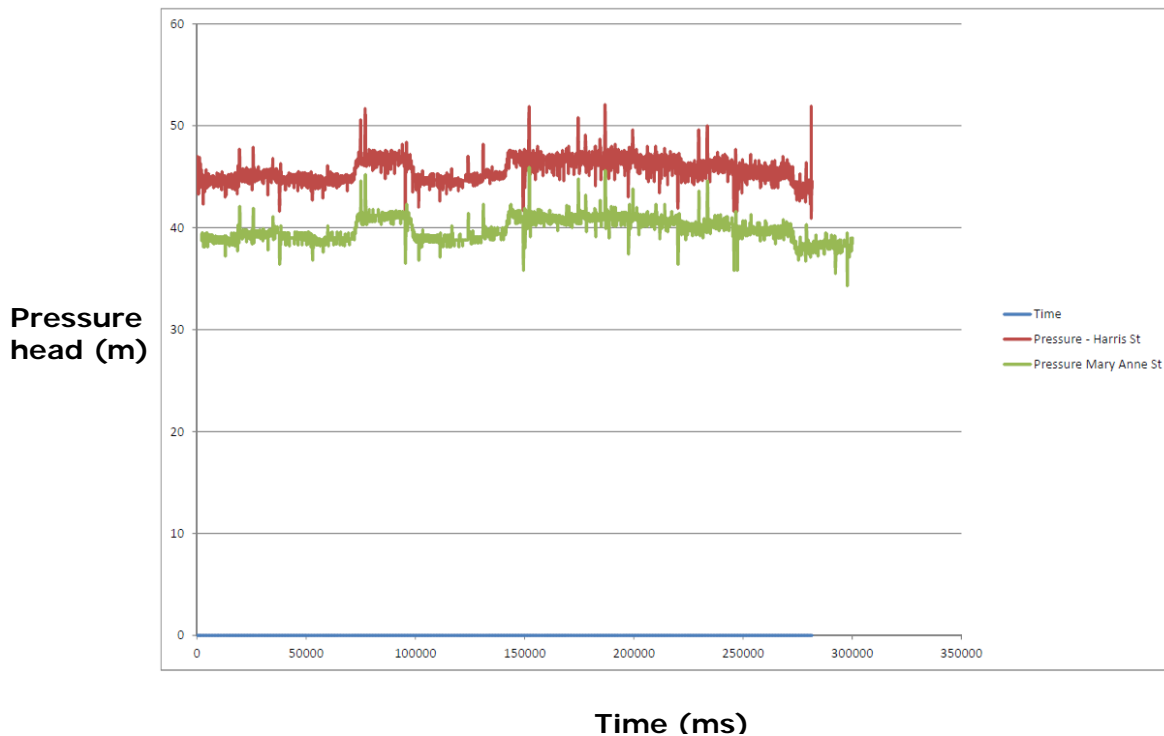
Figure 2-3 Measured operating pressures of the D500 pipes after the event (Ref. [7])

On the basis of pressure measurements undertaken (Figure 2-3, Ref. [7]), the maximum operating pressure of D500 is around 550kPa (including static and water hammer). It should be noted that any horizontal thrust applied on the D500 pipe due to water velocity in elbow configuration is neglected in this regard.

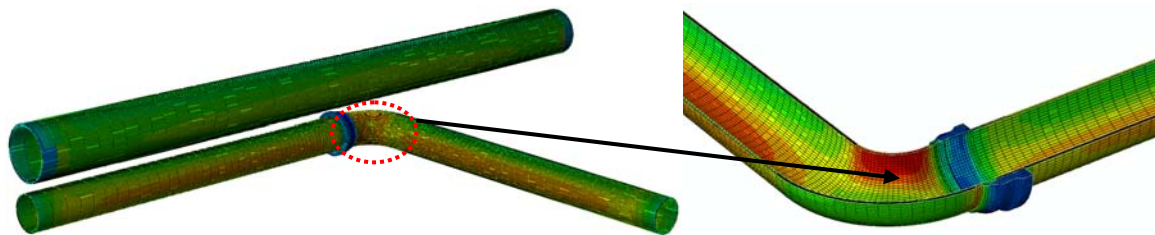
Figure 4-2 Pipe stresses (in KPa) during operation at no presence of pre-existing cracks; but insertion of a bell joint into the model

affected on maximum stress induced on D500 pipeline if no pre-existing cracks exist in the pipe.

$\sigma_{max} \sim 13\text{MPa}$

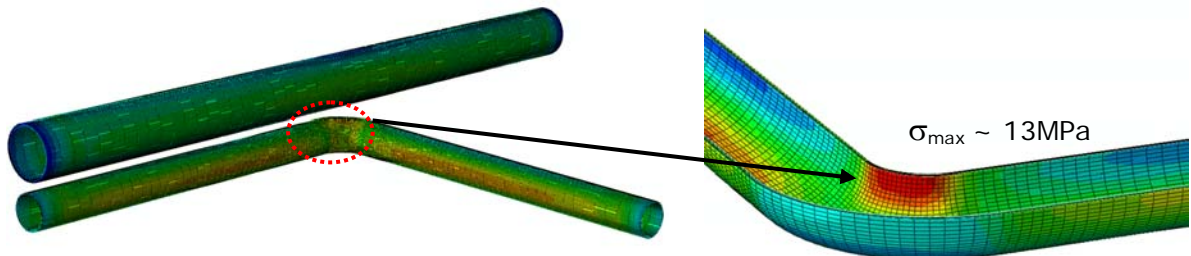
Figure 4-3 Pipe stresses (in KPa) during operation at no presence of cracks and joints

$\sigma_{max} \sim 13\text{MPa}$

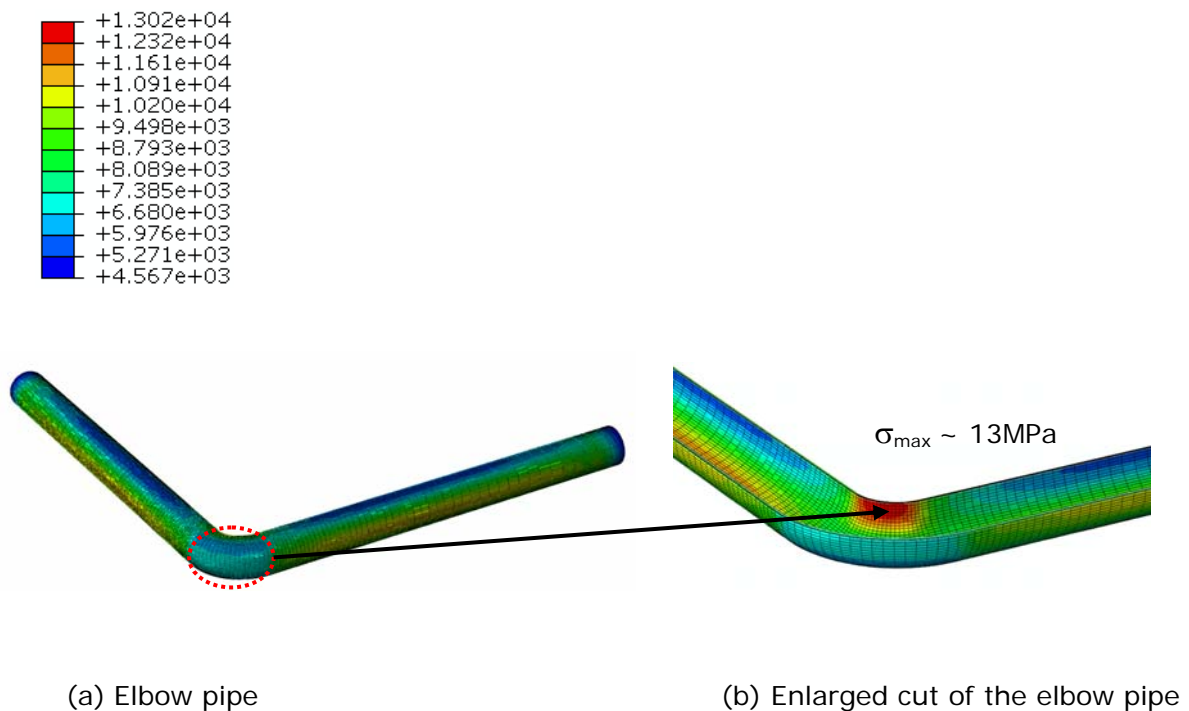
Figure 4-4 Pipe stresses (in KPa) during operation at no presence of over-laid D750 pipe as well as no pre-existing cracks

Analyses were also performed to see whether there were any effects from the over-laid D750 pipeline when operating at different water pressures (0.6MPa and 1MPa tested in the current study). Simulations were performed excluding the over-lying D750 pipe on the basis of the model without crack and bell joint. Results of the analyses are shown in Figure 4-4. As can be seen from the results, D500 pipe was induced a maximum stress of around ~13MPa similar to what was obtained at the presence of D750 pipe (see Figure 4-2). Further, maximum stress is only enhanced by 0.1MPa in D500 pipeline when the D750 pipeline is operated at higher pressures (i.e. 1MPa). This is because the deformations in D750 pipeline even at higher pressures are not substantial to increase soil loading beneath the pipe (i.e. above D500 pipeline).

- The results indicated that over-laid D750 pipeline appeared not to present major influence on the stresses developed in D500 pipeline. **This is because the deformations in D750 pipeline even at higher pressures are not substantial to increase soil loading beneath the pipe (i.e., above D500 pipeline).**

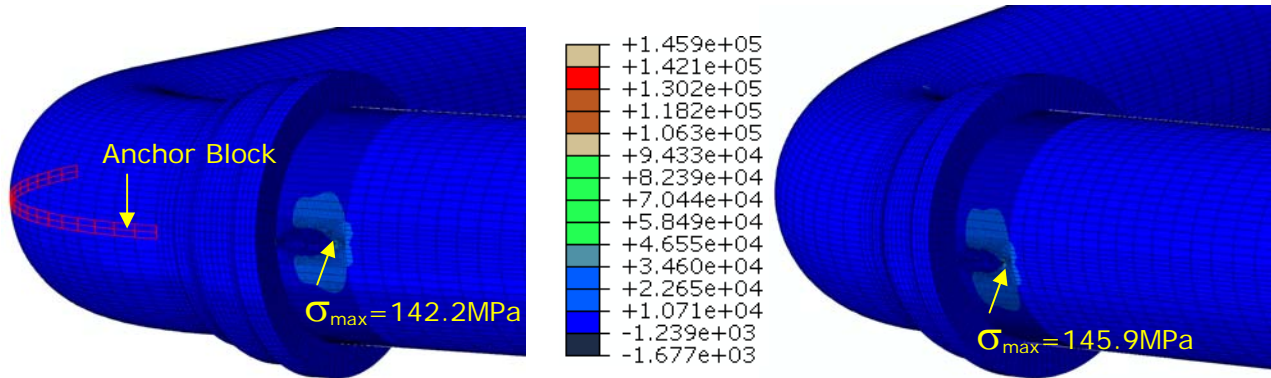
Figure 4-7 Stress comparison of the D500 straight pipeline (with crack; length 15cm) between the cases of with and without anchor blocks

The analyses results for the fracture models are shown in Figure 4-7 (a) and (b) for with and without anchor block models respectively. It shows that only ~3.5MPa difference in maximum stresses between the block and no block models. The influence of soil's contribution to restrain the pipe was not investigated.

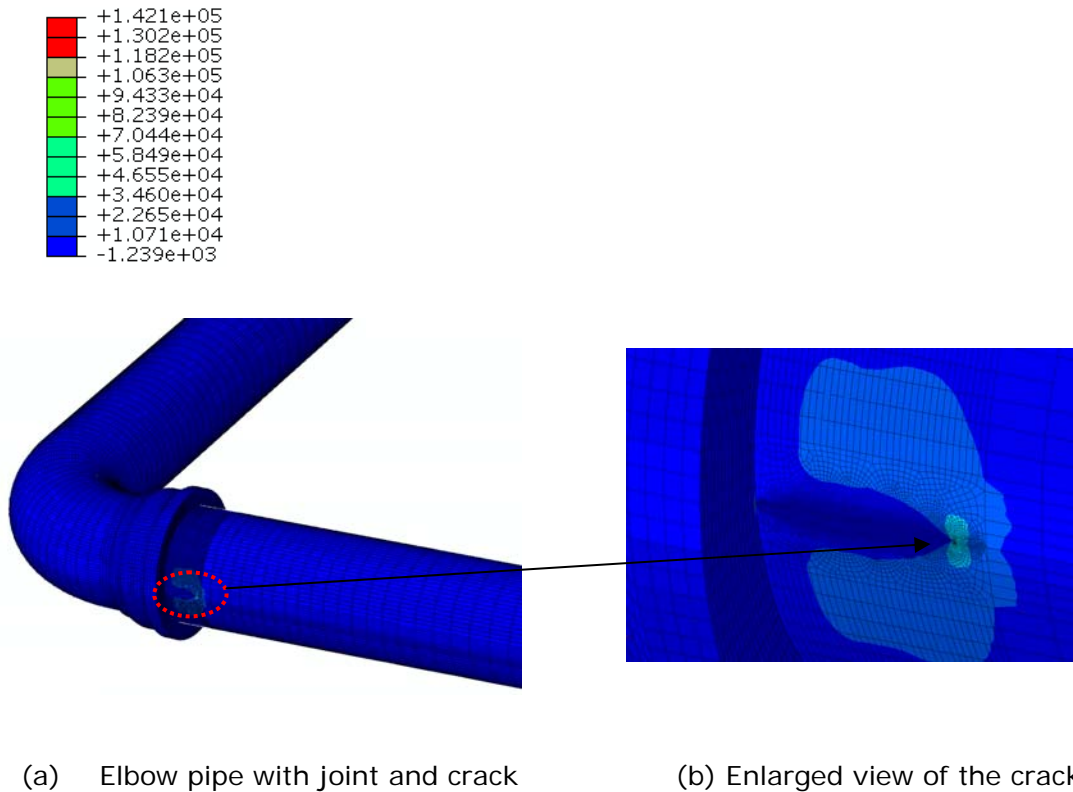
Figure 4-8 Pipe stresses (maximum principal) during operation at the presence of pre-existing crack in the bell joint (at a crack length of 15cm outside the bell joint)

It can be seen from the above analyses that the maximum stress in D500 pipeline would not exceed 13MPa during its normal operation provided that the pipe has no cracks or corrosion defects. However, the analyses undertaken by Metallurgist indicated that an older pre-existing crack was evident in the UL pipe (at a springline location) at the pipe bell end. Therefore, FE assessments were conducted to investigate the effects of a pre-existing crack located at the springline of the UL pipe (see Figure 4-8). Analyses were performed at different lengths of pre-existing cracks varying from 5cm, 15cm, 17.5cm, 22.5cm, 27.5cm, 32.5cm and 37.5cm. On the basis of bell dimensions assumed, the crack appears outside the bell section, once the crack length exceeds 17.5cm. Hence, the last five cases of crack lengths given above, represent unrestrained (outside the bell joint) crack lengths of 0cm, 5cm, 10cm, 15cm and 20cm respectively.

It can be seen from the results that the maximum stress of the D500 pipeline is always concentrated at the crack tip as shown in Figure 4-8.

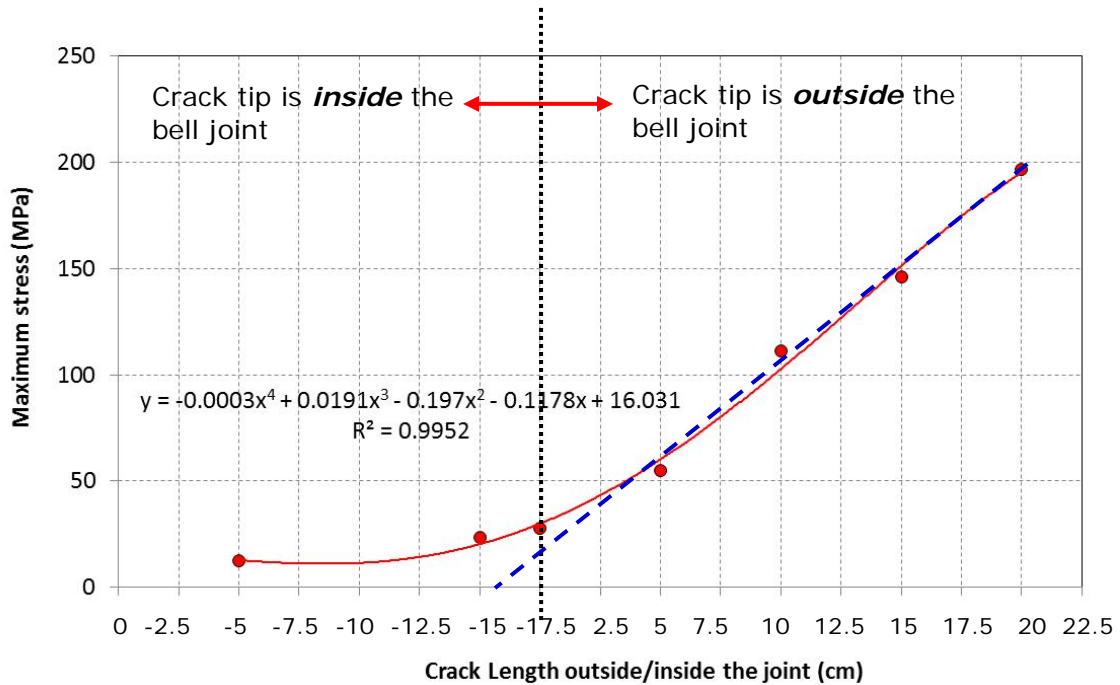
Figure 4-9 Variation of maximum stress in D500 pipeline at different pre-existing crack lengths

The results from all the analyses are summarised in Figure 4-9, in terms of maximum pipe stress observed at the crack tip versus the total crack length. The maximum stress increases at a smaller rate when the crack tip is inside the bell pipe. This is because the bell section can provide sufficient restraint to resist crack opening. Once the crack goes past the bell joint, the additional restraint is lost and hence pipe is subjected to larger stresses at the crack tip. Eq. 1 is calibrated to estimate the maximum stress (σ_{\max}) at a given crack length (l_{cr}).

Once the crack propagates to about 10-15cm beyond the bell joint (i.e., unrestrained crack length), the maximum stress reaches the likely tensile strength capacity of cast iron (General tensile strength of uncorroded spun cast-iron pipes can be more than 70MPa, Ref. [11]). For instance, the SW test bed pipe section gave a tensile strength of 100 MPa (Ref. [10]). These results indicate that

the pipe could undergo tensile fracture if the pre-existing crack propagated to 10 to 15cm outside the bell joint.

According to the trend of the FE stress results beyond the bell joint (blue dashed line in Figure 4-9), the maximum stress at the crack tip would have reached ~100MPa (i.e. possible tensile failure) when the unrestrained crack length becomes 12.5cm. This value is in good agreement with the failure crack length (i.e. 13.7cm) derived from FAD level 2 assessments.

- Results on with-crack model showed that the maximum stress increases at a slower rate when the crack tip is inside the bell pipe. This is because the bell pipe is capable enough to provide an addition restraint to resist crack opening. Once the crack started to appear outside the bell joint, the additional restraint is lost and the pipe is subjected to larger stresses at the crack tip. **Once the unrestrained crack propagates to about 10-15cm, the maximum stress reaches the tensile strength capacity of cast iron and hence the catastrophic failure would have occurred on the day.**

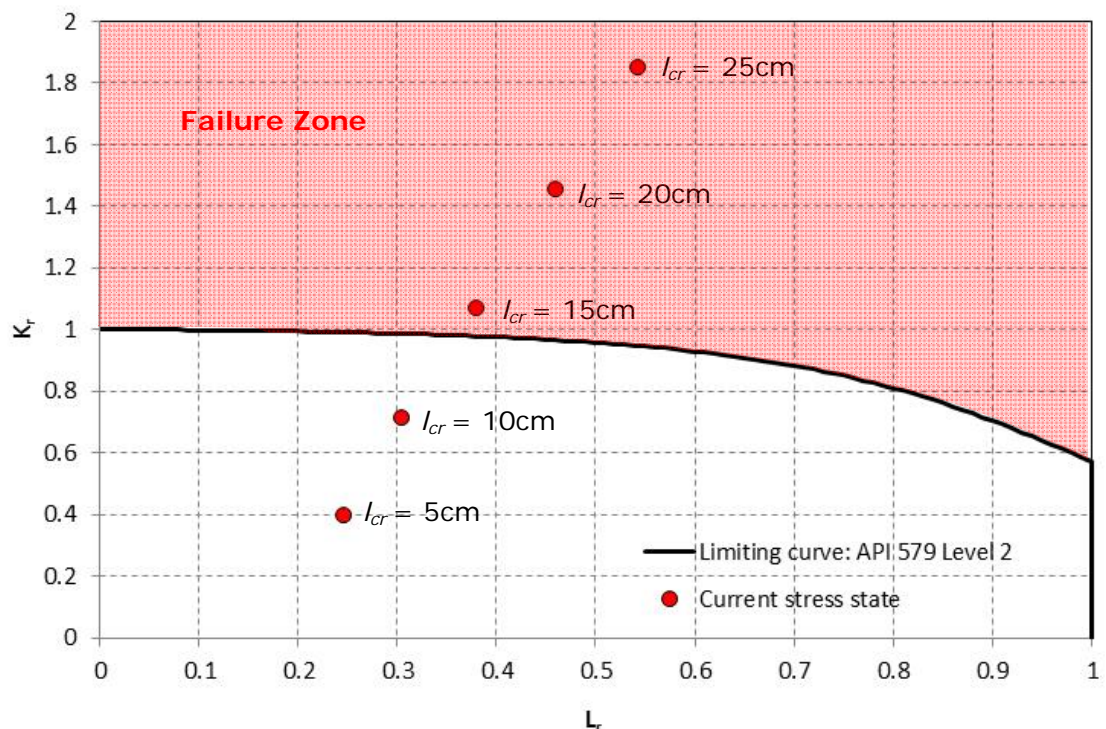
Figure 4-10 API FAD-Level 2 Assessment

The results of the assessments are shown in Figure 4-10 for D500 pipeline with different pre-existing crack lengths (5cm, 10cm, 15cm, 20cm, 25cm). It can be seen that the pipe fails once the pre-existing crack exceeds a length of 13.7cm. It should be noted that there are no provisions made in the Standard to cater for the effects from bell restraints. i.e. Results from the FE assessments showed only a mild increase in stress concentration (hence stress intensity too) when the crack tip is inside the bell joint. Once the crack is extended beyond the bell joint, stress started to increase rapidly. Such behavioural stress pattern does not capture in the current Standards.

- Failure assessments made on the basis of the fitness for service revealed that the pipe fails once the pre-existing crack exceeds a length of 13.7cm. It should be noted that there are no provisions made in the Standard to cater for the effects from bell restraints.
