Activity 2: Direct Condition Assessment Methods

Scope: Innovative Methods for Automatic Interpretation of Data Gathered from Existing Sensors

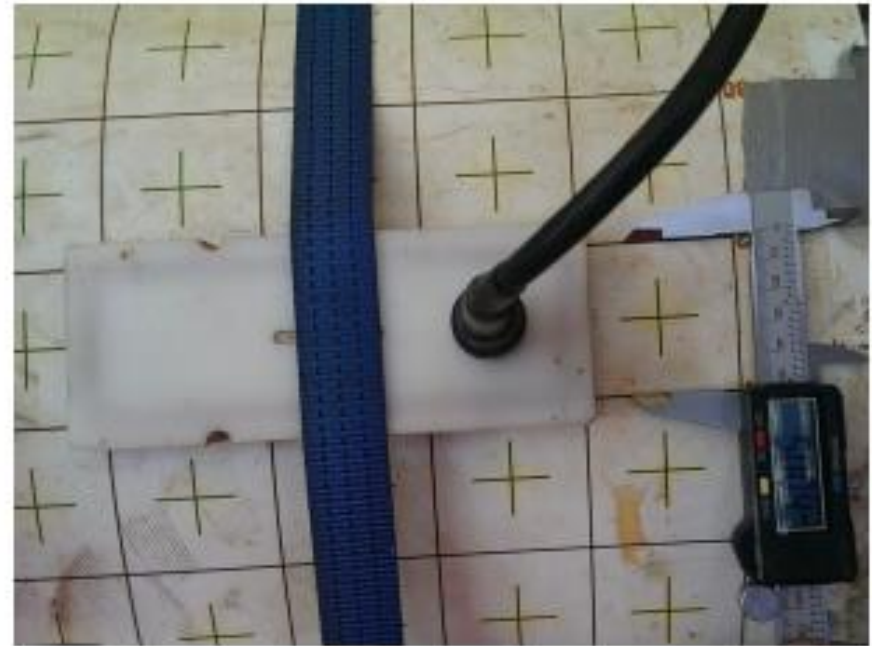
Broadband Electro-Magnetics (BEM): Brief Technical Description (cont.)

- The BEM coils need to be sufficiently large to energise the material in order to detect thickness of Critical Mains
- This is not a point measurement, rather a domain measurement
- Eddy currents detected belong to the energised **volume** of material beneath the sensor, it is a measure of **averages**
- Regular grid used to place sensor

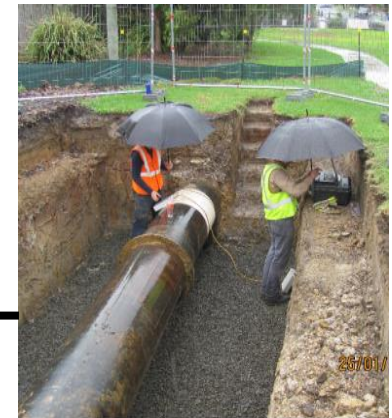
Data Interpretation Mode (Analytical or Probabilistic)

Testing data from pipe

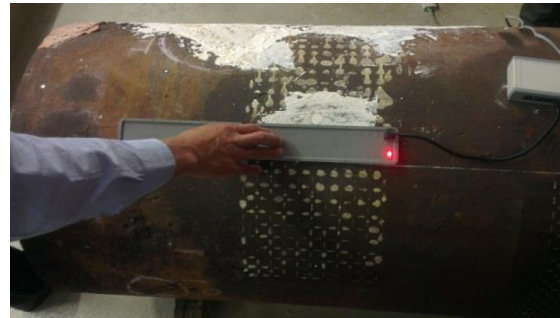
Analysis from Trial 5 (Anomaly 1)

Statistical Parameter	Value
Root Mean Square	2.4369 mm
Mean Absolute Error	2.0256 mm
Standard Deviation	1.3553 mm
Maximum Error	7.2712 mm
Percentage Accuracy	90.0705%

- UTS interpretations for both (Trial 5 and Perth trial) were done using simulations based on material properties extracted from the Sydney Water test bed (660 mm CI pipe)
- The overall percentage accuracy for the Perth trial (350 mm CI Pipes) was observed to drop to 78% in contrast to 90% for Trial 5 (from test bed)
- We hypothesize this to be attributed to variation of material properties of the 350mm Cast Iron pipes from Perth from those of the test bed. Steps have been undertaken to confirm this, we are currently awaiting analysis of coupons from UoW
- Parallel XRF analysis as a more straightforward, proxy field test for material property analysis, will be done on all Trial pipes after completion of scheduled (final) Trial 6

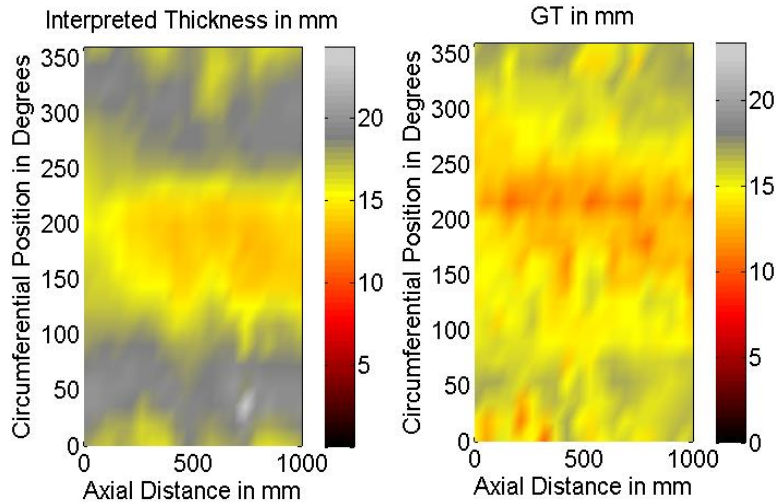
A Sample Pipe Section

Analysis from Perth Trial

Statistical Parameter	Value
Root Mean Square	3.8905 mm
Mean Absolute Error	3.2041 mm
Standard Deviation	2.2078 mm
Maximum Error	9.7405 mm
Percentage Accuracy	78.0463 %

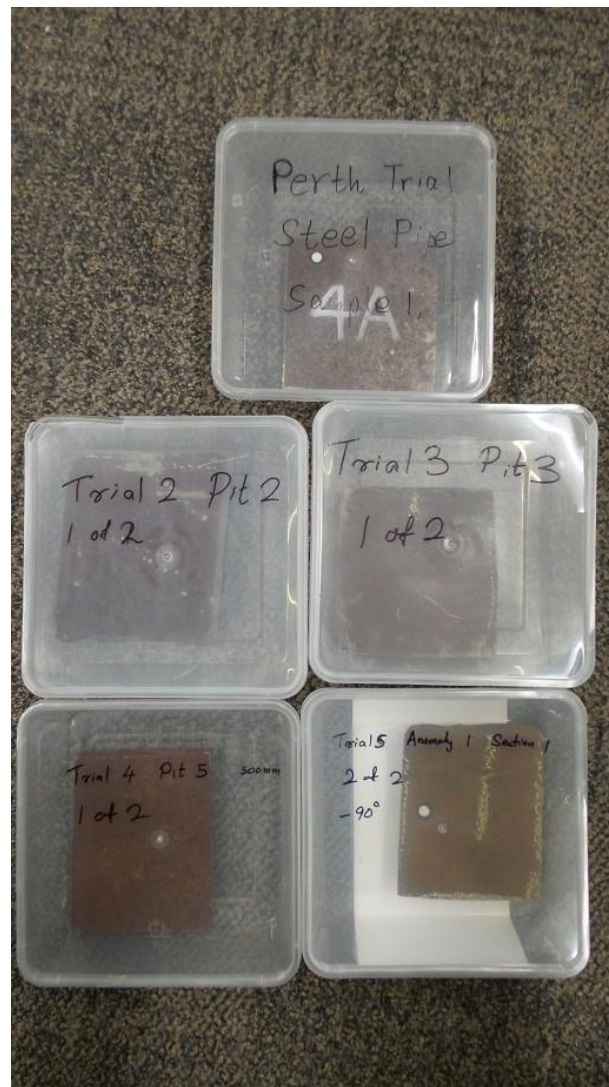
- Coupons have been extracted from different locations of the test bed segments and from pipes from Perth
- Coupons have been sent to UoW for measuring electrical and magnetic properties using a Quantum Design Physical Property Measurement System (PPMS-9T)
- Currently awaiting specimen preparation and laboratory testing to be performed to carry on further analysis

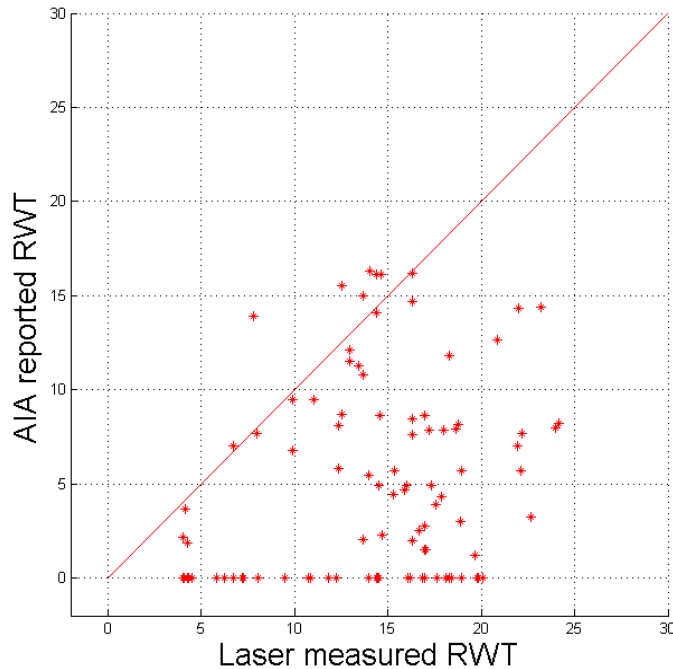
AIA vs. laser (GT) RWT
AIA Results RMS error : **11.20mm**

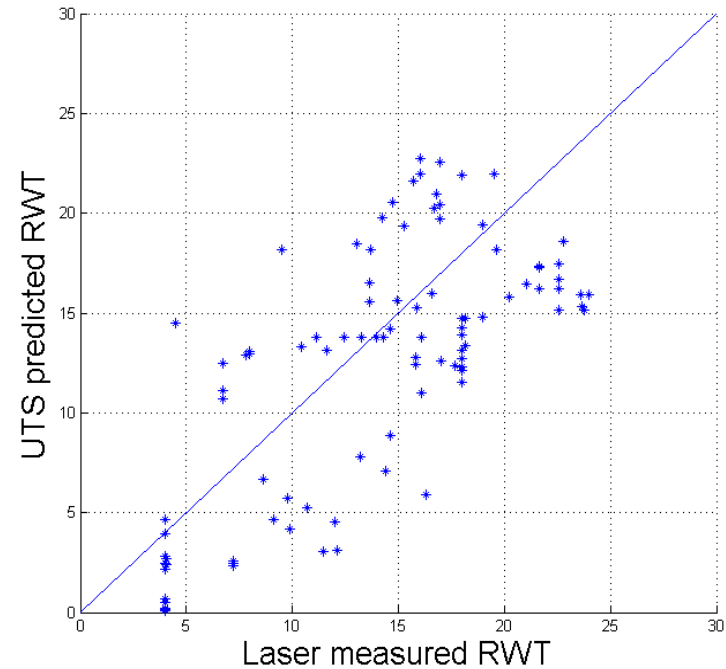
UTS vs. laser (GT) RWT
UTS Results RMS error : **4.79mm**

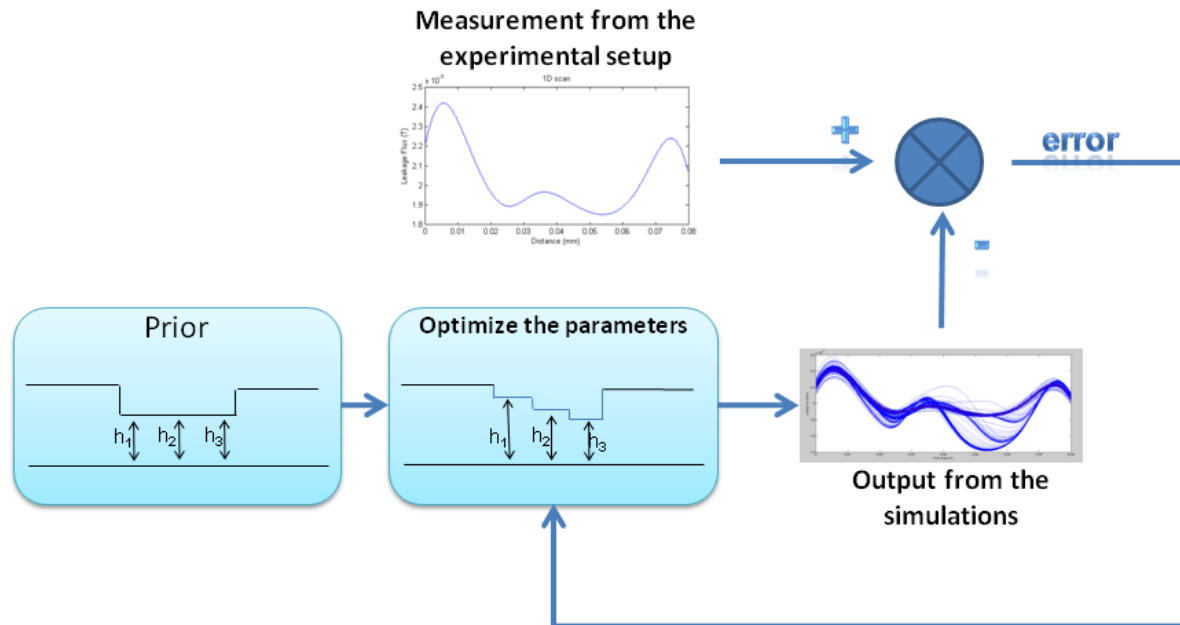
Iterative Coarse to Fine Approach

- Investigated a close-to-optimal FEA sensor model through global optimisation methods
- It complements current GP proposition for higher accuracy
- The initial results are convincing yet computationally intensive

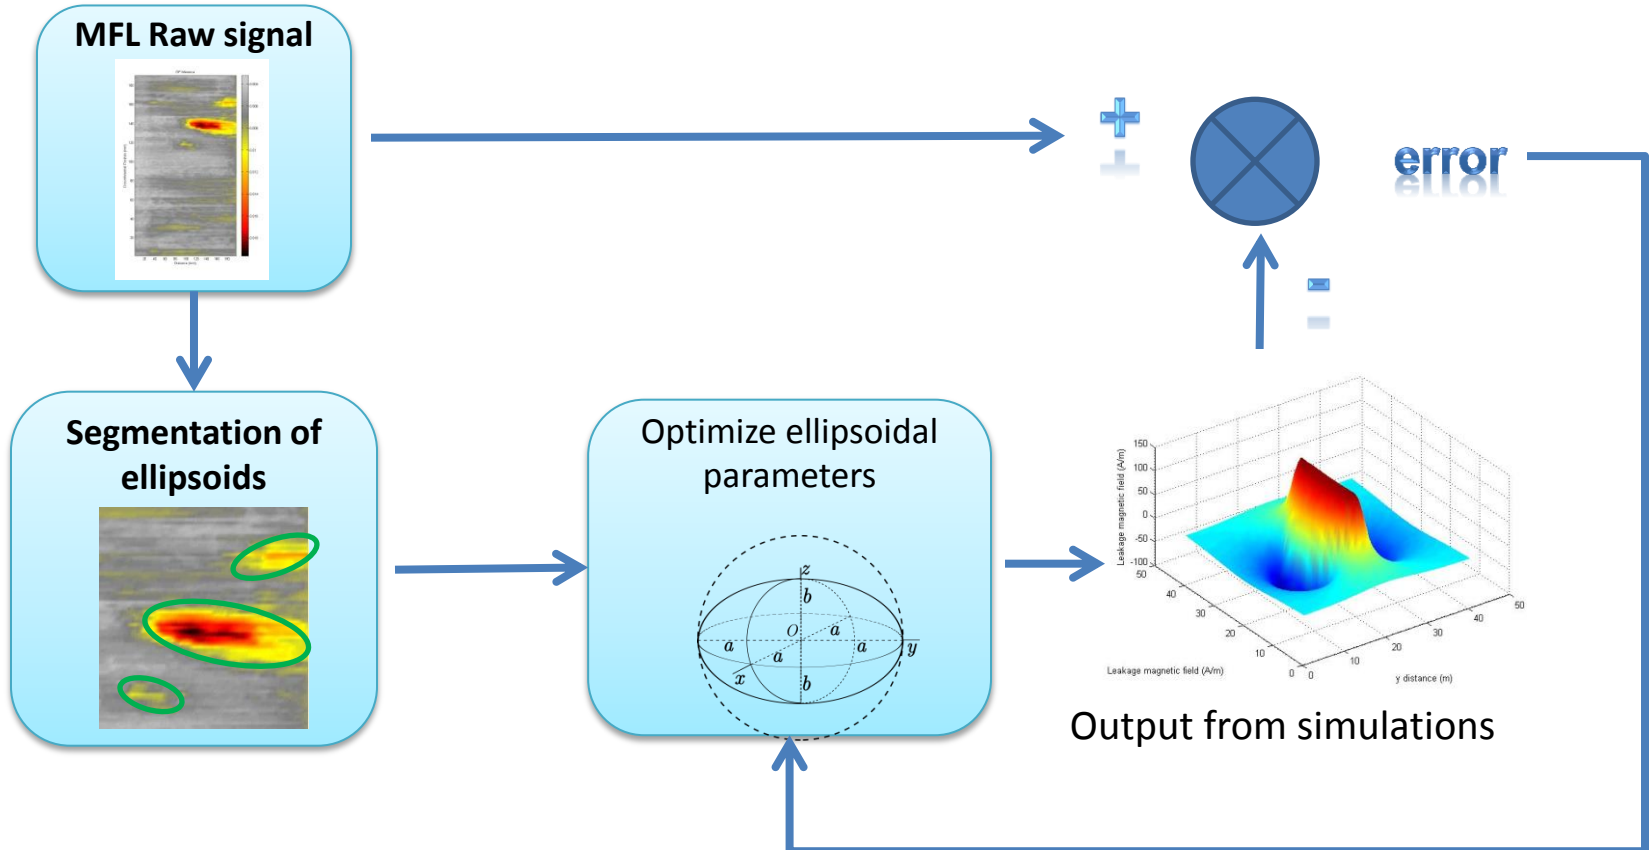
Iterative Ellipsoidal Approximation of Defects

- The importance of ellipsoidal approximation of defects has been identified for stress analysis purposes

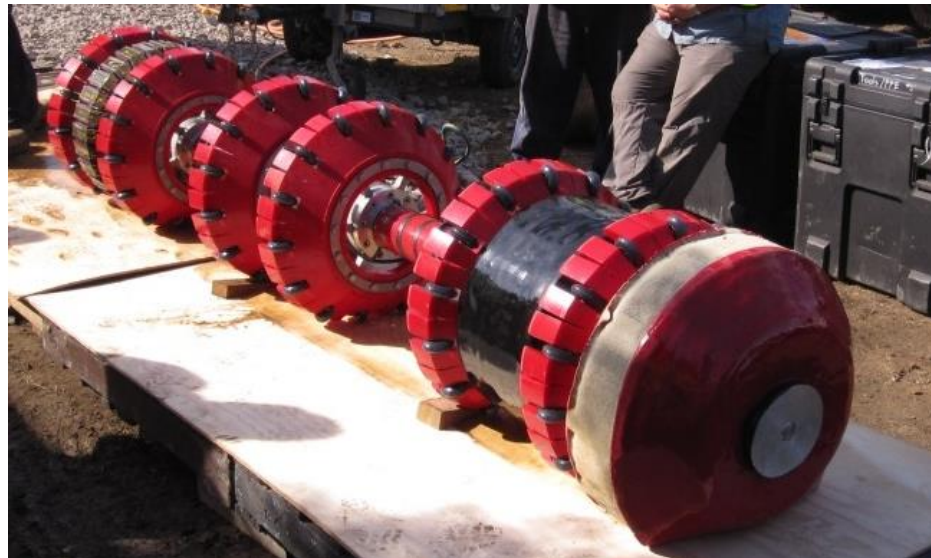
Remote Field Technology (RFT): Technical Description

- RFT technology detects changes in an AC electromagnetic field generated by the tool that interacts with the metal in the pipe, becoming stronger in areas of metal loss
- The electromagnetic field interactions are measured by on board detectors and processed on the tool
- Dedicated analysis software is applied to generate accurate information on the wall thickness

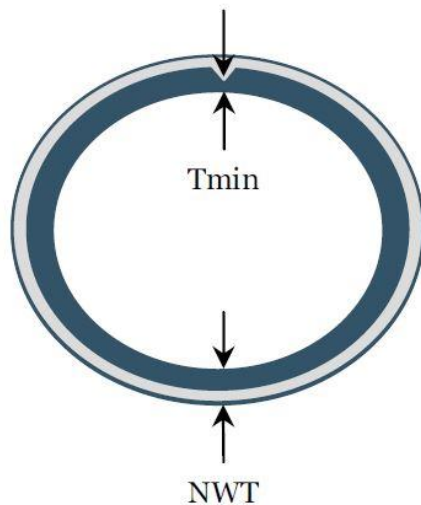
Image taken from Russell NDE Report 2012

TCircMin: Minimum circumferential value

RW: Average RWT for the full pipe segment (~3.6m)

TCircMax: Maximum circumferential value

Defect: Up to 3 defects are reported at a given location and point-wise minimum thickness

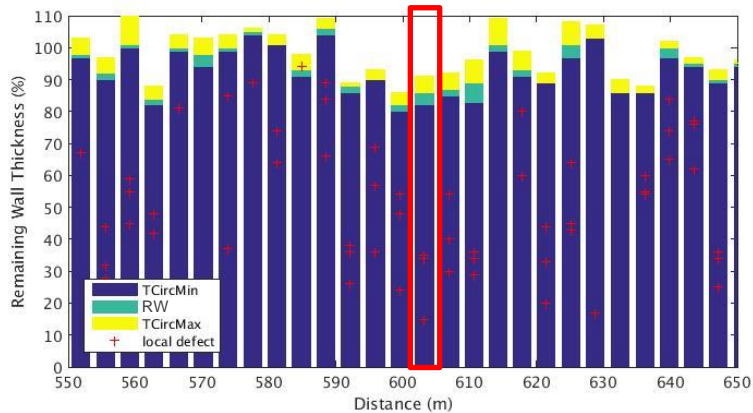
Data Reported by Russell and Ground Truth (GT) (Trial 2 – Pit 3)

RW = 86%
TCircMin = 82%
TCircMax = 91%

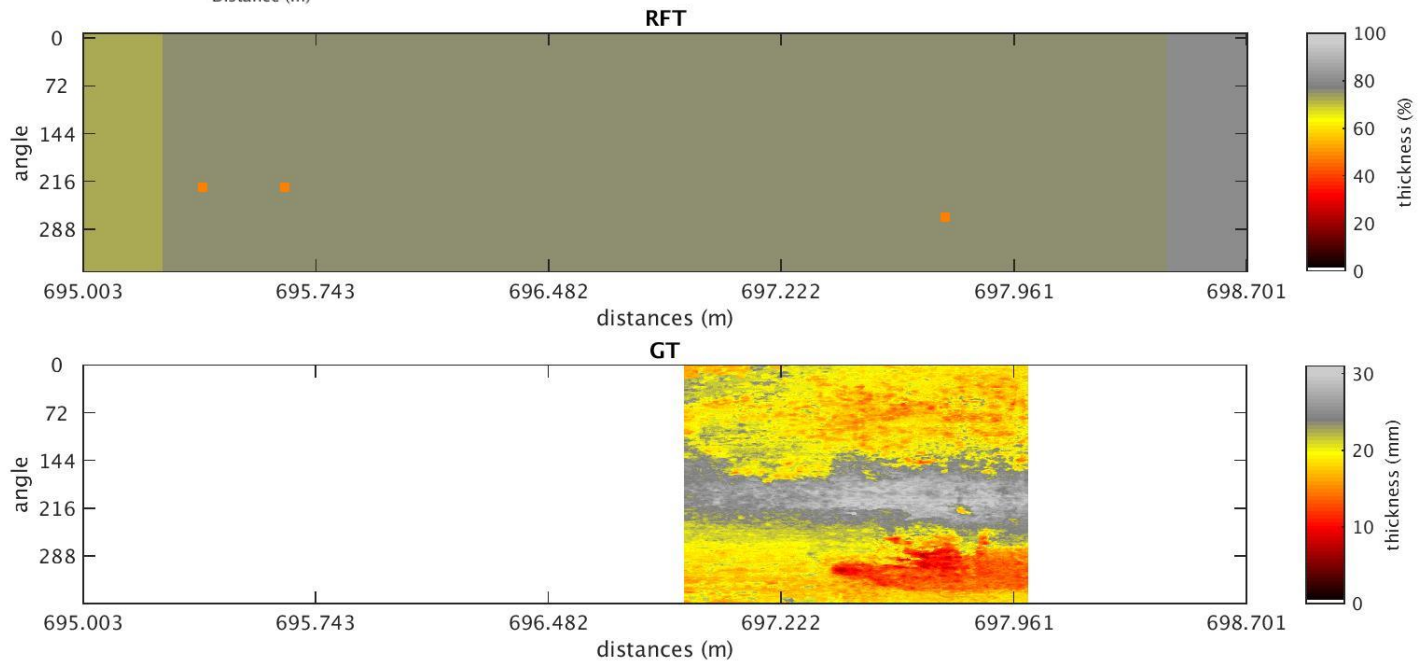
Data Reported by Russell and Ground Truth (GT) (Trial 3 – Pit 3)

RW = 76%
TCircMin = 72%
TCircMax = 81%

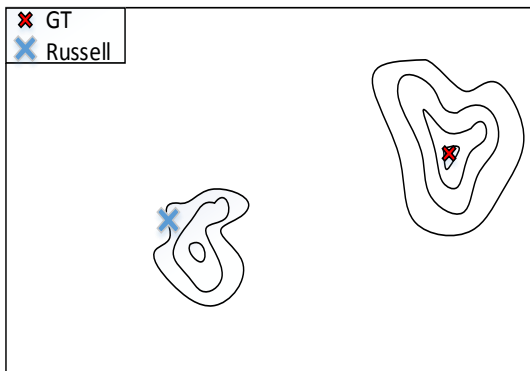
Defects: Minimum Pitting

- Thickness of the worst defect reported by Russell vs. actual worst RWT in the 1 m pipe segment (GT brought to RFT resolution by averaging)
- In some cases, there are worst defects than those reported by Russell as worst

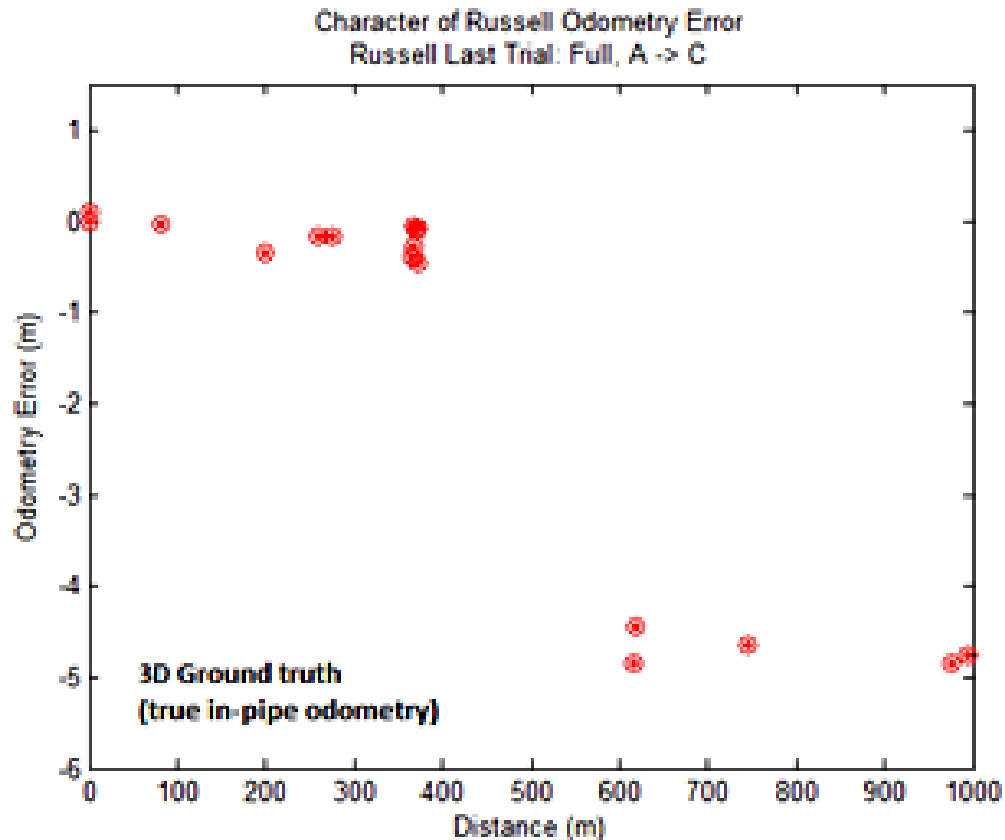
RFT Tool Localisation Issues

- As tool moves inside the pipe there is location inaccuracies, characterised as:
 - About -5 meters at the river crossing area
 - ± 1 meters error everywhere else

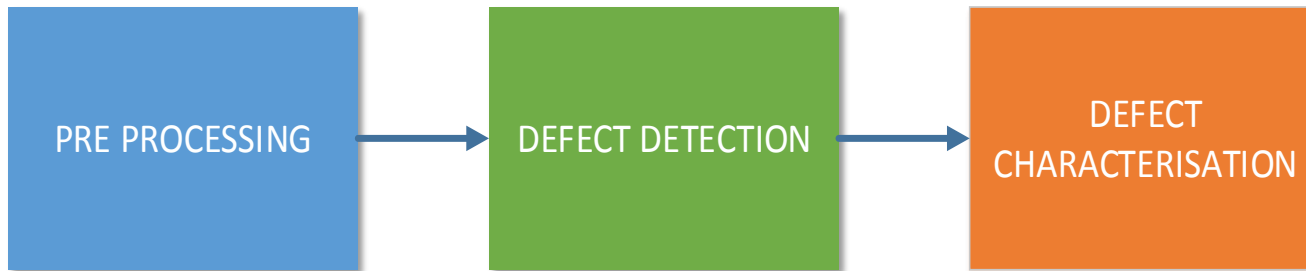
UTS Processing of RFT Data for Defect Detection

- The pre processing of the RFT data has already been implemented including:
 - background removal algorithm and
 - further filtering process able to remove most of the noise sources
