TAC meeting Oct 2013

Activity 3 presentation

Field work

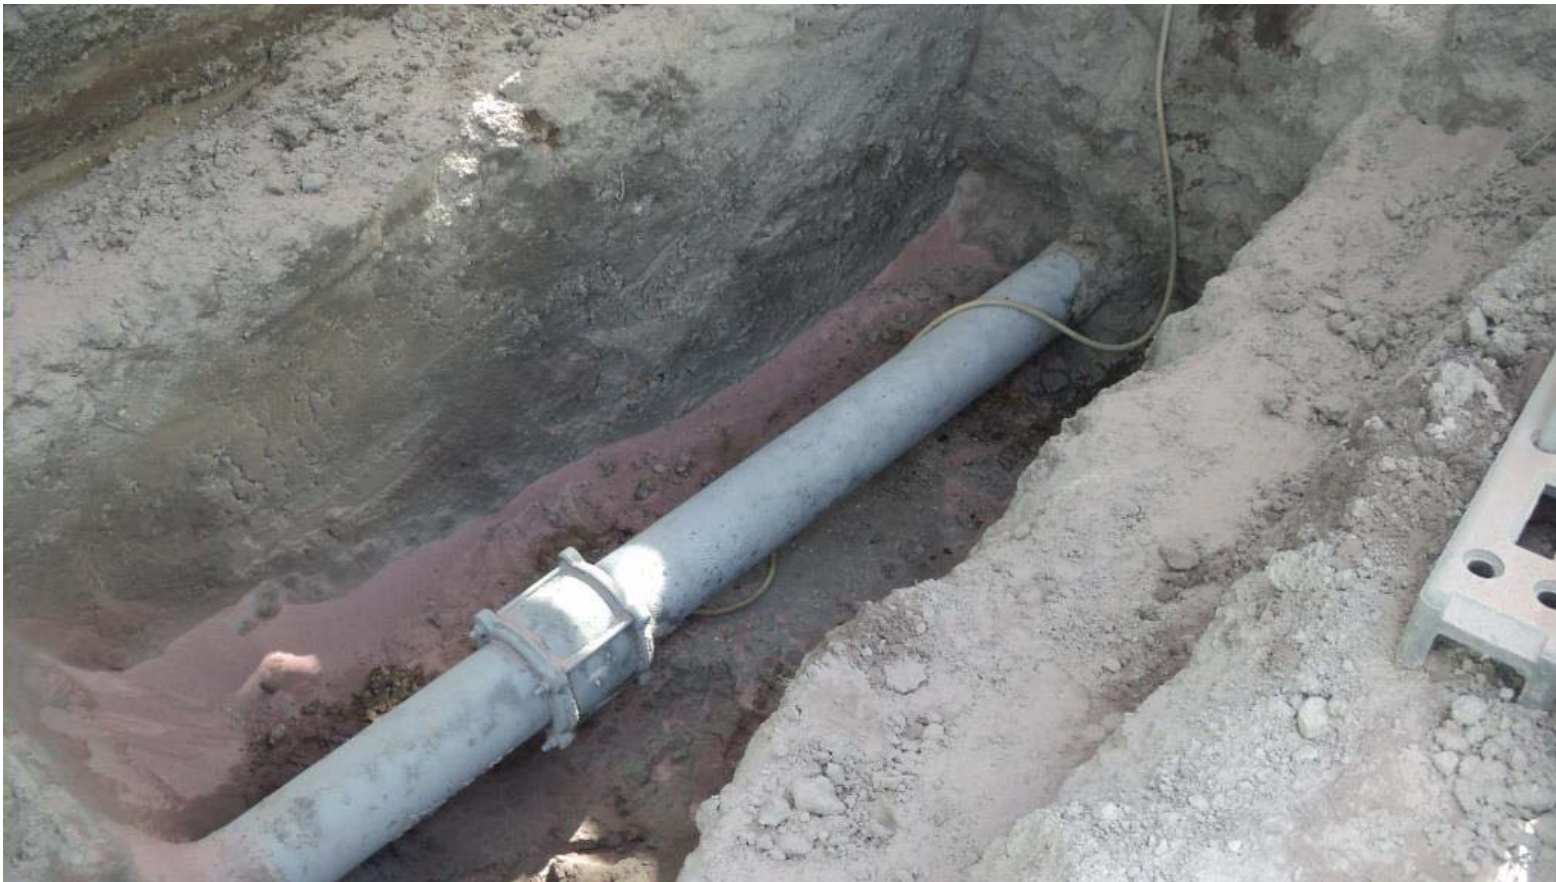
Field work – Native clay backfill sites

- Looked at maximum corrosion depth
- Data from sites separated into following categories (based on backfill):
 - Native clay backfill (11 sites)
 - Sand surround (2 sites)
 - Native sand backfill (2 sites)
 - Other (5 sites)

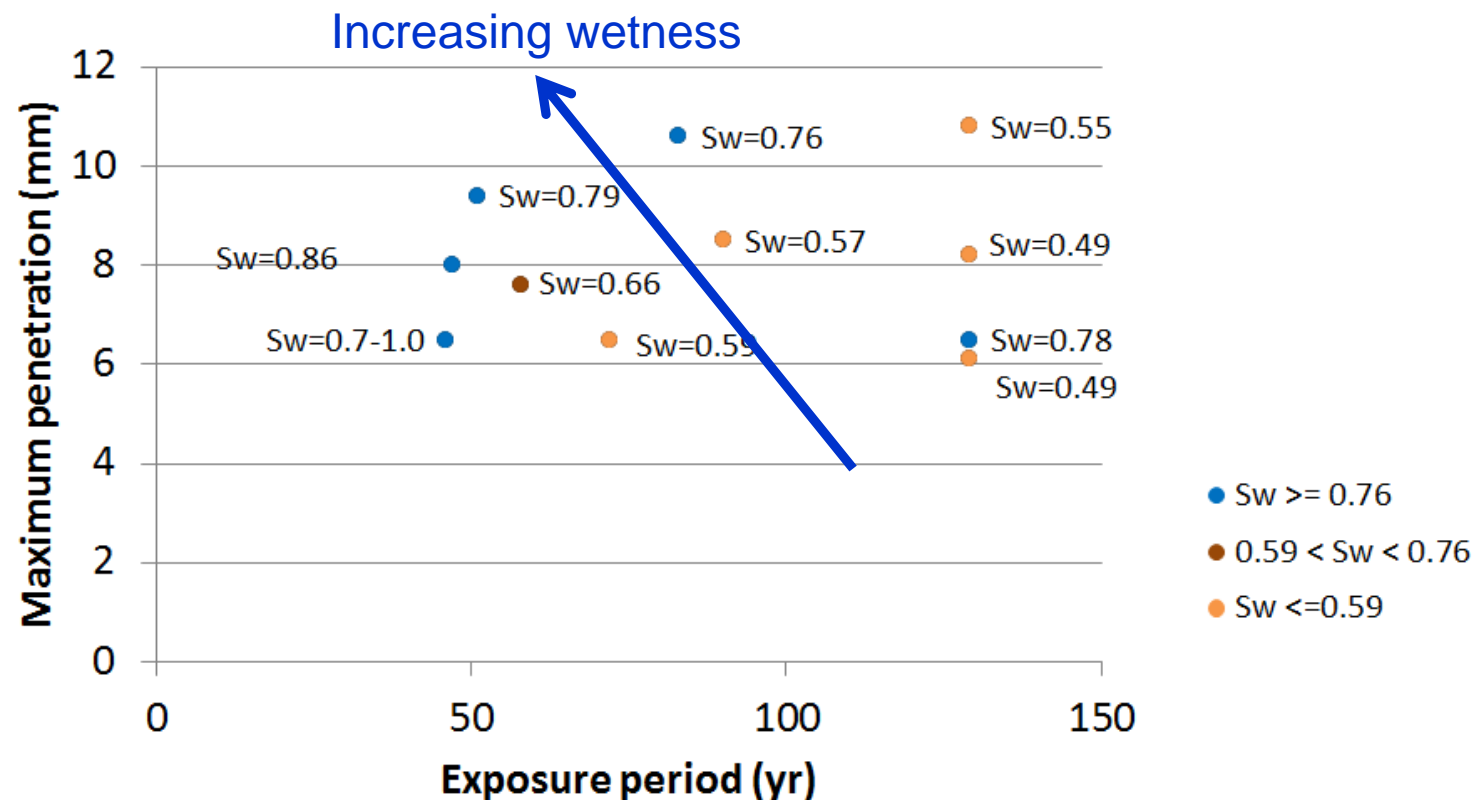
Field work – Native clay backfill sites

- Soils predominantly clay
- Reasonably uniform/homogenous
- First investigated the influence of moisture on maximum corrosion depth
- Assumed moisture content measured at time of inspection a reasonable approximation of long-term moisture content

- Sw = degree of saturation

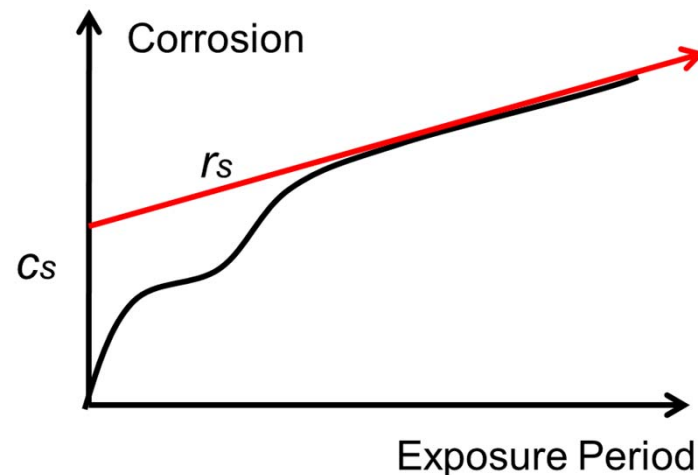
Initial model calibration – clay sites

- Data used for to fit long-term corrosion model
- Fit straight line to field data
- Construct corrosion vs. time data using short and long-term data from similar environments
- Preliminary calibration – corrosion a function of soil moisture

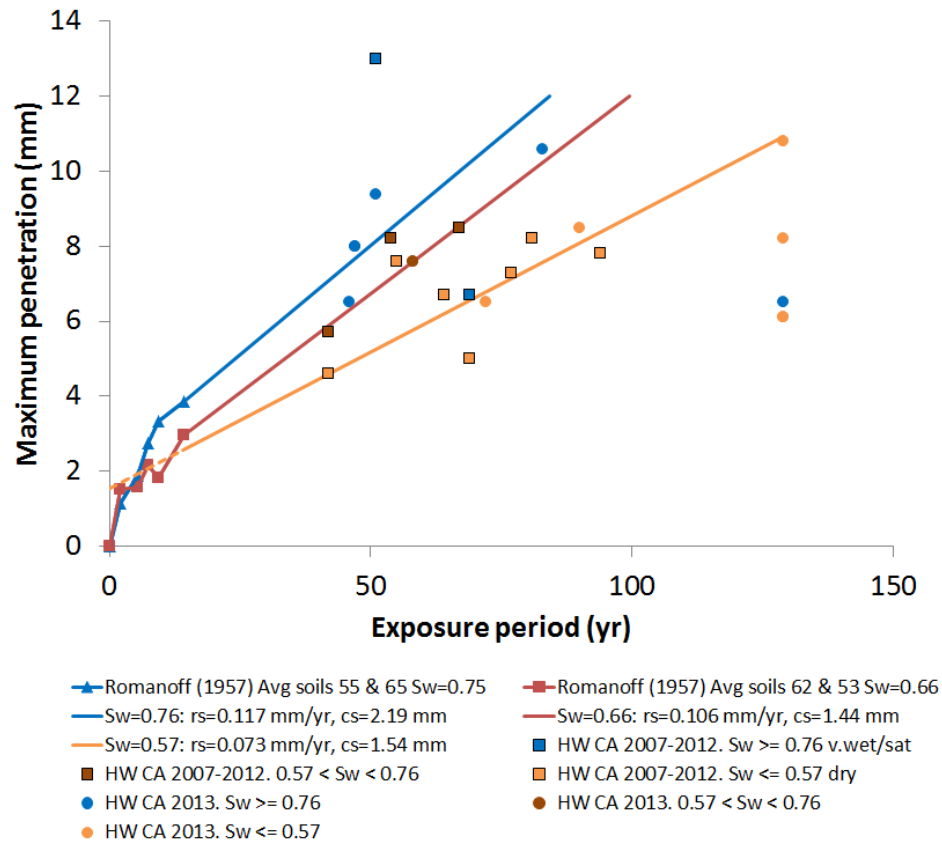
HW CA (2007-2012) – clay sites

- Native clay soil data from previous and current Hunter Water Condition Assessment studies

- Data consistent with 2013 data
- (dry sites low corrosion, worst corrosion wetter sites)
- To make data useful for model calibration –
- Propose additional work to sample soils at sites to determine soil properties:
 - Texture
 - Moisture content
 - Density

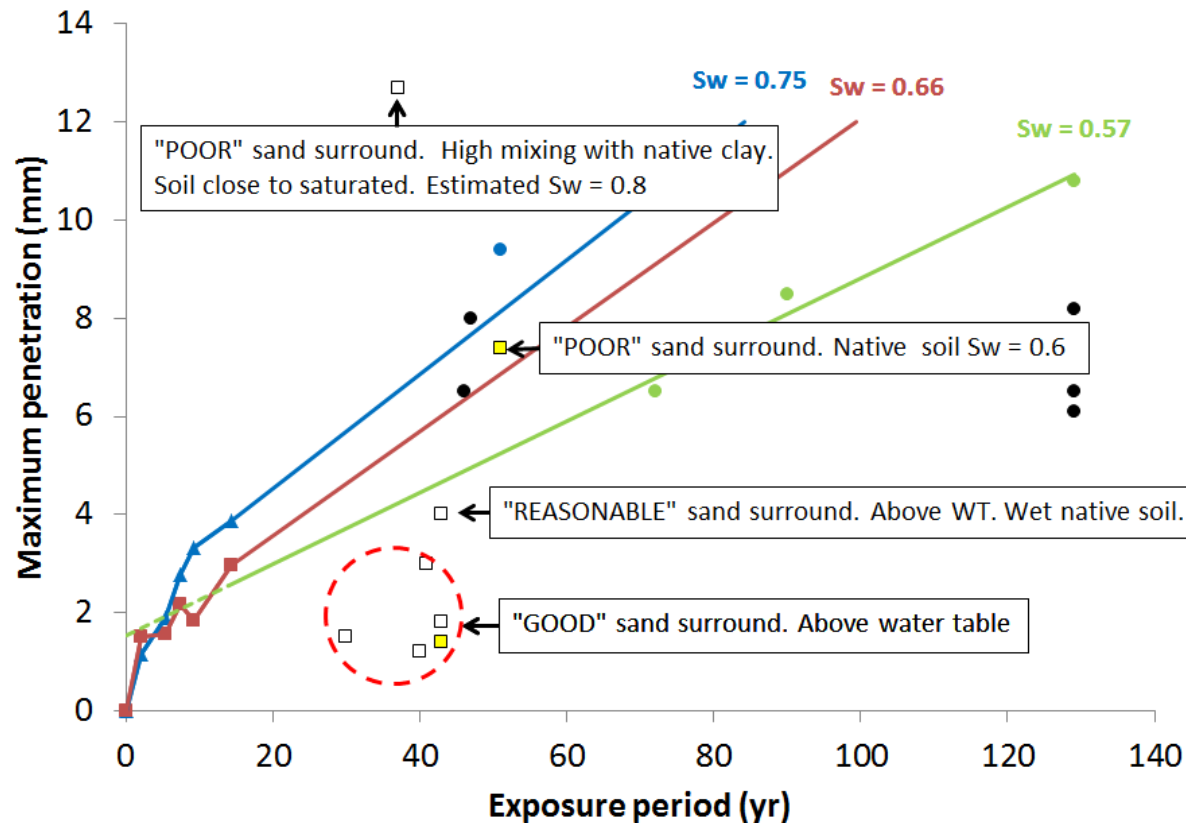
HW CA (2007-2012) – sand surround

- Data points sand surround superimposed on native clay soil data (2013 data)

- Findings
- Sites with good quality sand surround above water table: relatively low corrosion
- Poor quality sand surround in very wet conditions (native soil = clay): relatively high corrosion
- Corrosion likely to be a function of:
 - Degree of intermixing with native soil
 - Native soil type
 - Soil moisture next to pipe

- Findings
- Initial estimate for poor quality – observed corrosion appears to lie in range expected for native soil without surround (maybe even higher)
- All cases of good sand surround above WT, expect to be reasonably well drained and dry.
- No cases of good sand surround under WT or partially submerged

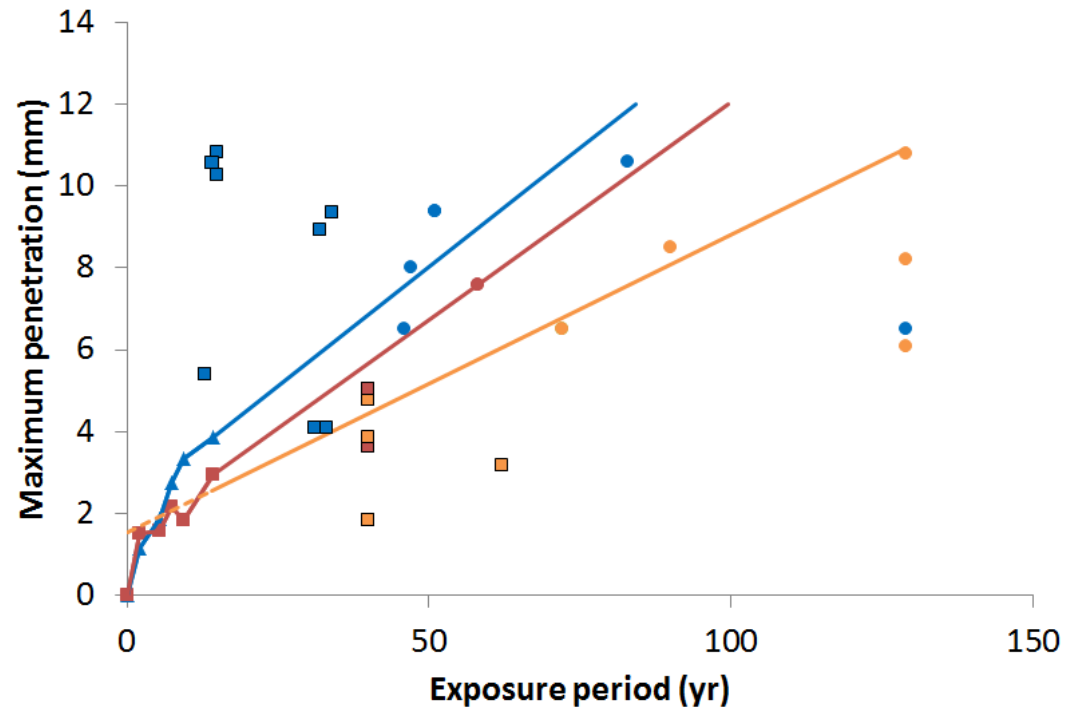
Hay (1984) data – deepest pit vs time

Loam and sand data superimposed over HW CA (2013) clay data

- General trend: corrosion (deepest pit) increases with wetness
- Can data be used for model calibration?
- 1st step: Need to improve confidence in long-term average moisture content.
- Consider model
