TECHNICAL NOTE

Project: Advanced Condition Assessment & Pipe Failure Prediction Project (ACAPFP)

Title: Review on Harris Street/Ultimo Lane Water Main Failure

Ref.: Monash-ACAPFP-
Activity1-TN1

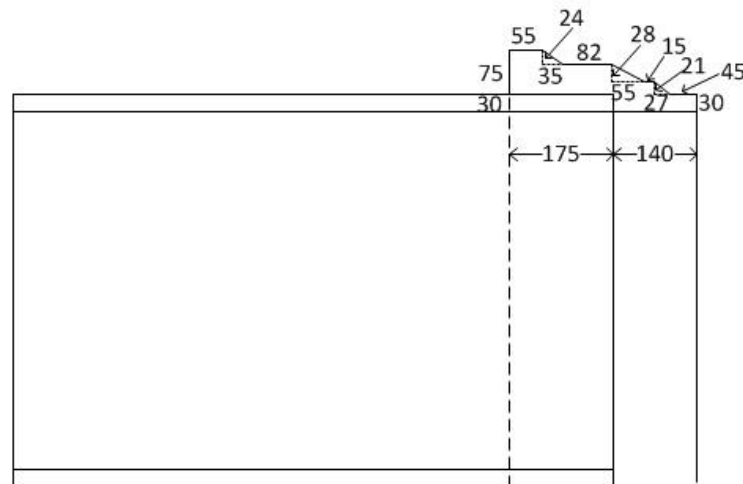
Figure 2-2 Assumed dimensions (in mm's) of the bell

The dimensions of the bell used (see Figure 2-2) in the analyses are based on measured dimensions of a bell joint of a pipe section retrieved from Sydney Water test bed pipeline. Accordingly, the straight pipe (i.e. UL pipe shown in Figure 2-1) has a length of 175mm into the bell pipe as shown in Figure 2-2.

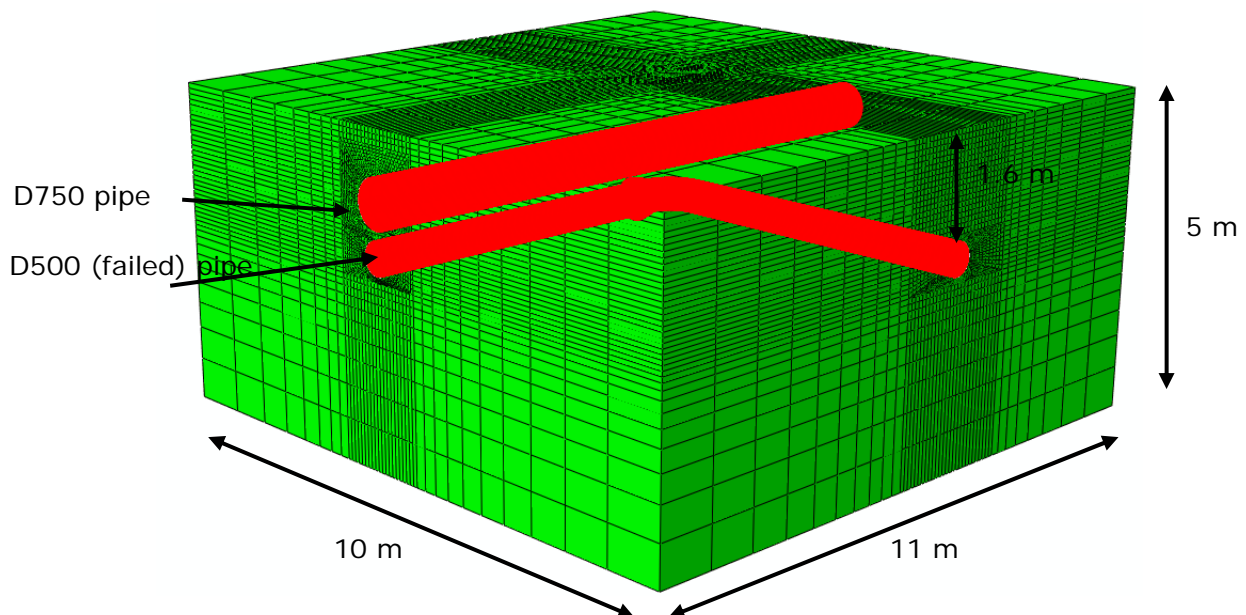
Figure 4-1 FE model idealisation and mesh discretisation

Three dimensional (3D) finite element analyses were carried out using ABAQUS 6.12 (Ref. [1]) to obtain the pipe stress conditions in current investigations. The pipes as well as the soil were represented by 8-noded brick reduced integration elements and the behaviour of both pipe and soil were assumed to be linear elastic. The soil side boundaries of the FE model were assumed to be smooth and are located far (i.e., 5m) from the pipe (& traffic loads) to eliminate any boundary effects. Figure 4-1 shows the mesh discretization (158,000 3-D elements to represent the soil and 220,000 3-D elements to represent the D500 pipe) and model dimensions. The appropriate dimensions and the mesh density of the model were selected after a number of trials to minimise mesh and boundary effects on the calculated pipeline stresses. It is to be noted that the element size around the area of the crack is selected as 1mm (this is based on an outcome from a separate study). The interaction between pipe and soil was modelled using Coulomb frictional model with a coefficient of friction of 0.5.

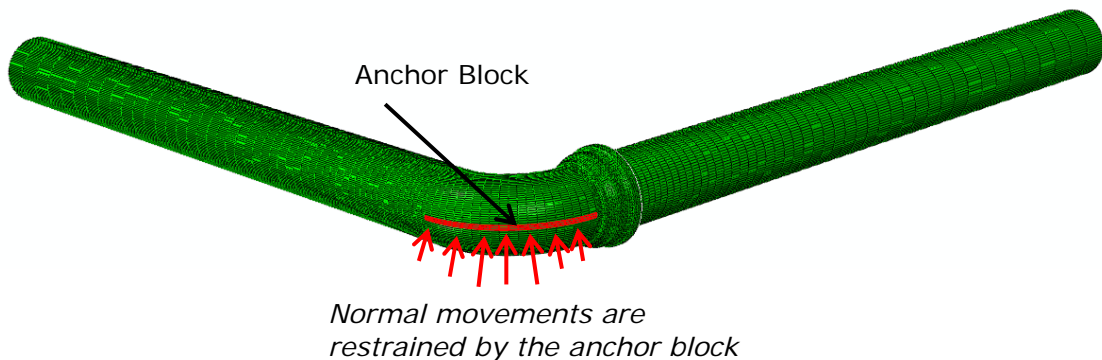
Figure 4-5 Implementation of the influence of the anchor block into the model

The effect of the anchor block was introduced into the FE model by specifying a local coordinate transformation to a set of nodes at the edge of the elbow in order to introduce horizontal restraints normal to the pipeline (see Figure 4-5).
